Intel[®] Celeron[®] Processor Specification Update

Release Date: March 2002

Document Number: 243748-043

The Intel[®] Celeron[®] processor may contain design defects or errors known as errata, which may cause the product to deviate from published specifications. Current characterized errata are documented in this Specification Update.

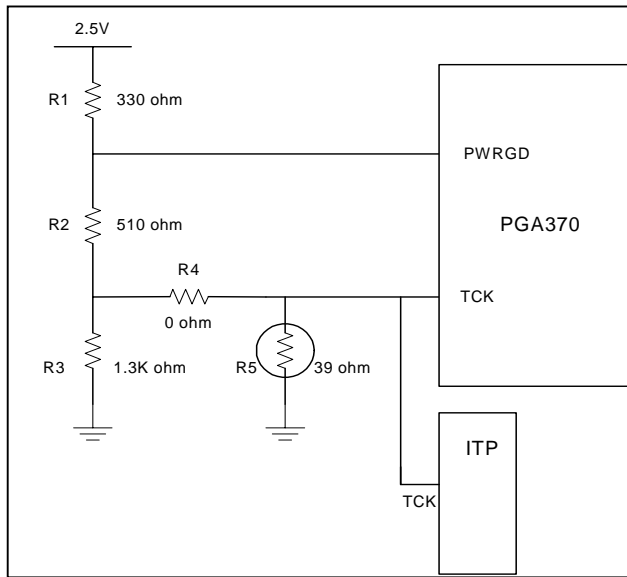
Figure 1 Celeron® on 0.13 Micron Processor 256K Platforms Workaround

In addition, the example workaround circuits shown do not support production motherboard test methodologies that require the use of the processor JTAG/TAP port. Alternative workaround solutions must be found if such test capability is required.

For Production Boards:

Depopulate R5
